# Volkswagen Cabriolet DIY Guide

## Repairing Selector Shaft Stop Finger

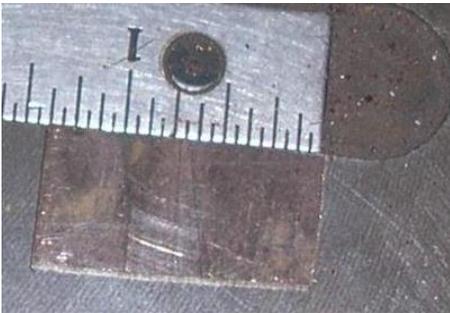
I chose a small piece of brass, a nut, and a bolt. I would have preferred to use bronze, but I haven't got bronze in sheets, and I had brass readily available.

The piece I used was 1/8" thick, and about 1.4" by .5"

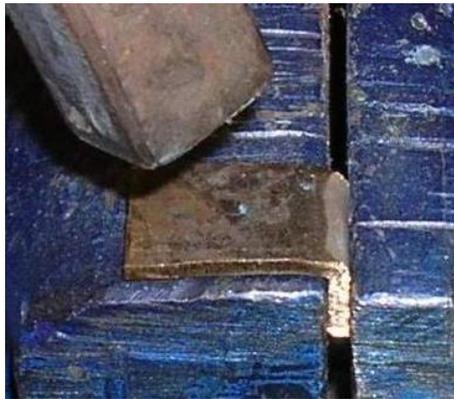
I hammered it into an L shape:

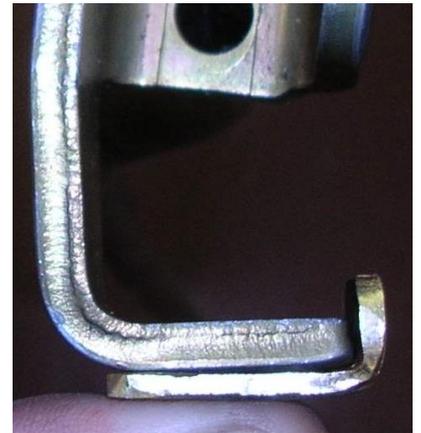
Test fitted:

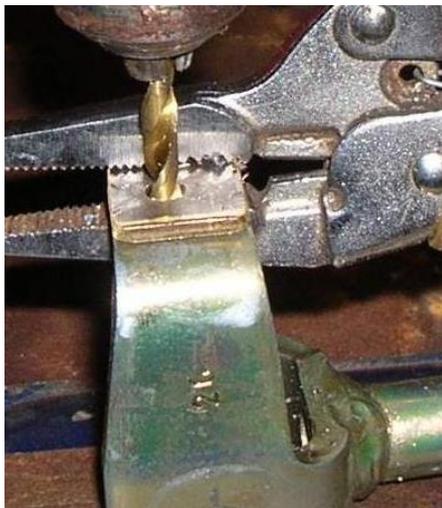
Clamped it together and drilled it:

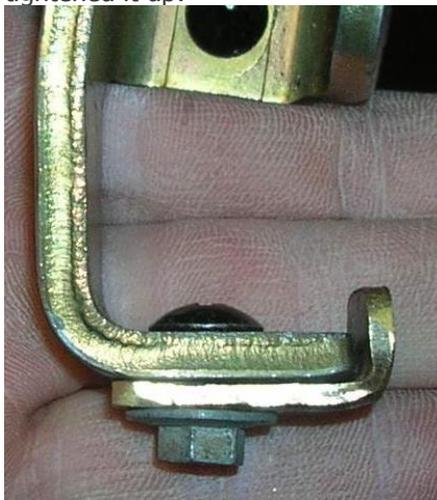
then I stuck a bolt through it and tightened it up:

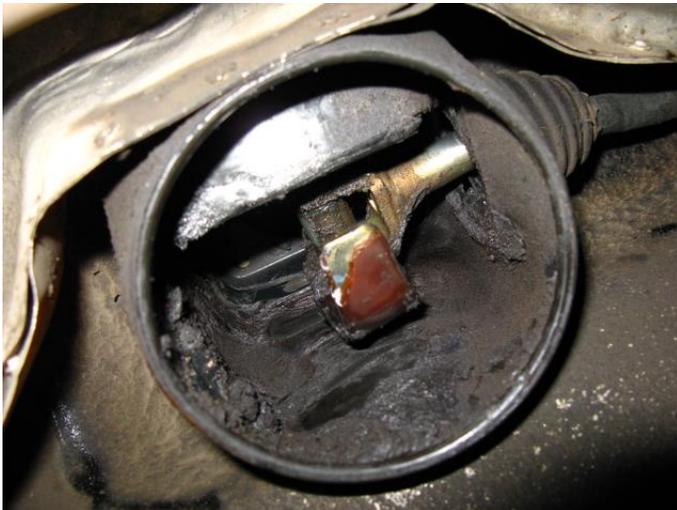
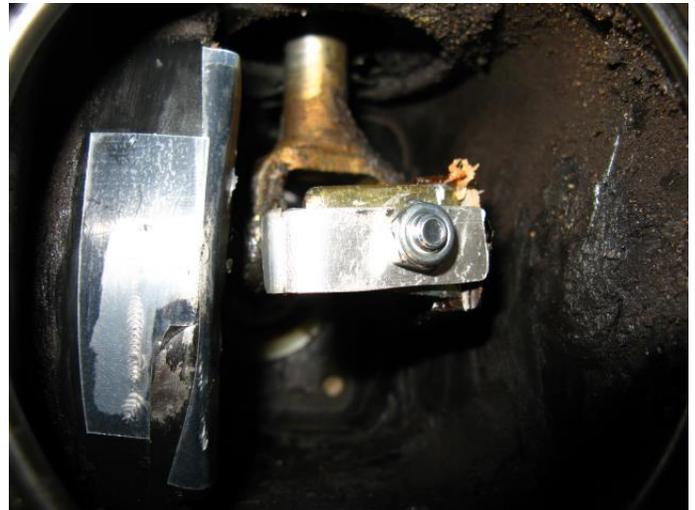
I cleaned up the disgusting, greasy mess on and around the lock gate and then applied UHMW tape to the gate and to the new stop finger (if you don't know what UHMW tape is, Google it). I did this for two reasons: 1) as added metal-on-metal contact protection; 2) as easy, non-messy lubrication so I could do a quick test-drive. [Update 2018: Do **NOT** use UHMW tape! Exhaust heat destroys it and turns it into a gooey mess.] You could also Plasti-Dip the part. A healthy serving of grease was applied once the selector rod was properly aligned.

The new stop finger will eventually be welded to the selector shaft for a more permanent solution, but so far the quick fix is working well. [Update 2018: Could not be welded due to dissimilar metals. A rivet was added instead. Couple years later, repair is still going strong.]
