Volkswagen Cabriolet DIY Guide

Loose Steering Shaft | Steering Bearing Replacement

Steering Column Bearing Replacement

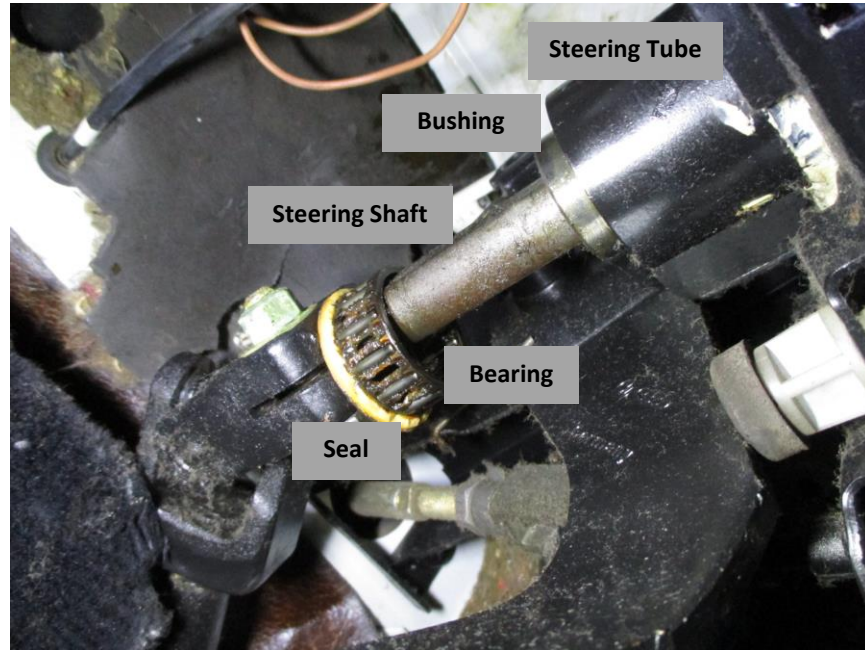
You're driving along and, while making a turn, your steering wheel moves a bit (or perhaps a lot), be it vertically and/or laterally. It may make a slight knock as well. What's wrong? Most likely, the bearing at the bottom of the shaft has slipped off its bushing due to a disintegrated, or worn out, seal.

Can this issue be easily fixed and can it be done without steering column removal? Yes! However, this should really be a temporary repair because, as seen in the photo above, the two-piece bearing has actually separated and is no longer doing its job as effectively as it should be. What the original components looked like:

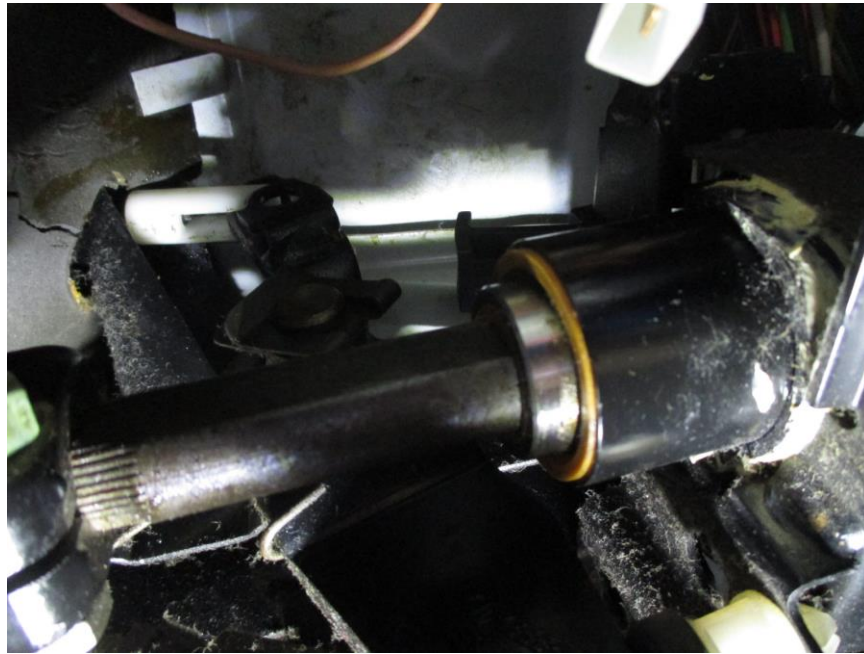
Slide the bearing back over the bushing and up into the steering tube. If the seal is still present, slide it back over the bushing until it's flush with the tube.

Not seen in the photos, but recommended: Wipe the bearing as clean as possible and re-grease it.

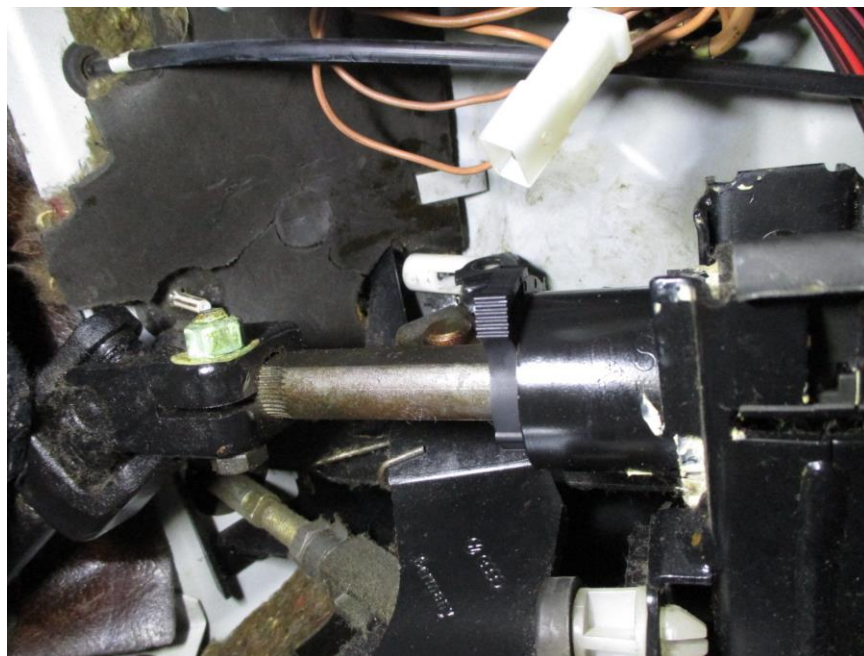
Find a hose clamp (plastic click type), or zip-tie large enough to fit 1" or 28mm and install tightly around the bushing.

Ensure the clamp or tie doesn't slip off the bushing. Done!

Note: It is advised that you not use a screw-on clamp. The reason for this, is that since this is a telescoping column, in the case of an accident, there is a possibility that a screw-on hose clamp could interfere with the collapsing nature of the column, which is a safety feature. A plastic version, or zip tie, will, seemingly, slip off the bushing, thereby not interfering with the safety feature.

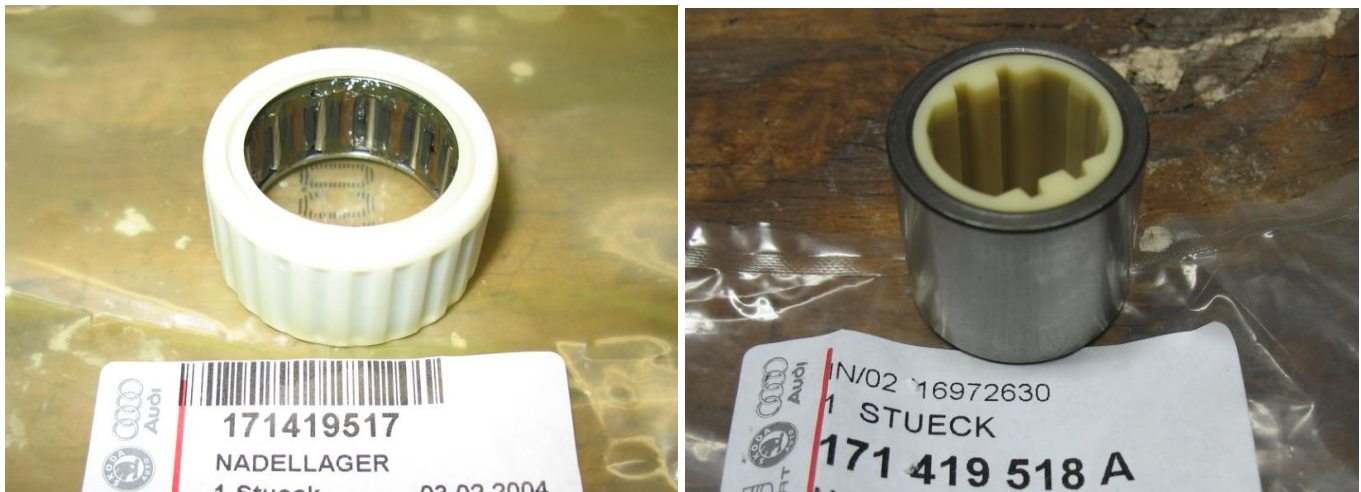
So I consulted ETKA at work and ordered a new bearing for the column tube (part #171-419-517)...

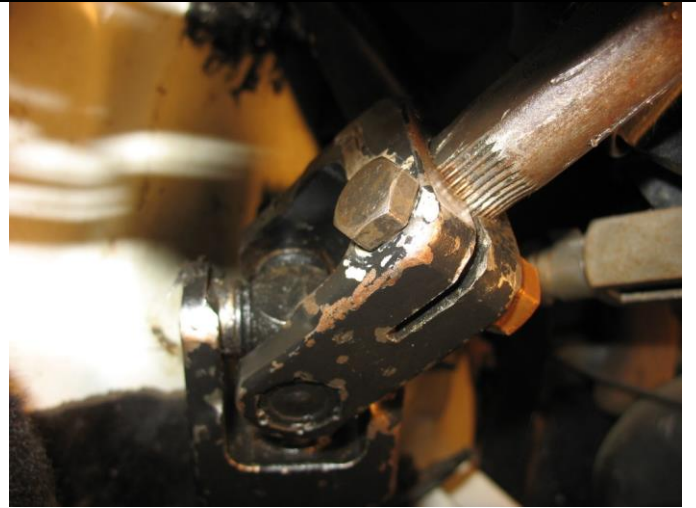
Follow the steering column down to the the U-joint and undo that 13mm bolt. [Ed. note: You may want to mark the steering shaft and bracket for depth and position before loosening the bolt so that you can ensure exact placement upon reinstallation.]

Remove the bolt and with some wiggling, the column should free from the end of the U-joint shaft by pulling the column assembly towards the back of the car.

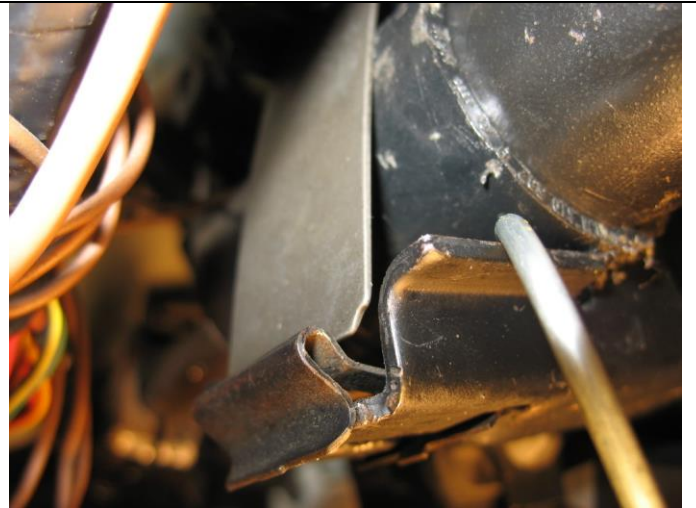
Undo the spring that clamps the column tube to the pedal cluster.

The column assembly should now be free to remove from the car. Be mindful of your wiring harnesses and grounds while extracting the tube.

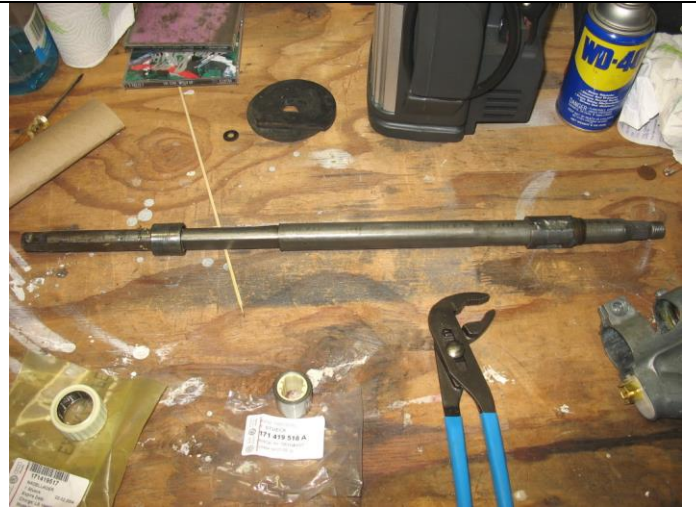
This is the steering column stripped of its tube. It is a 2-piece, telescoping unit, with the splined-half on the left sliding into the lock cylinder housing-end on the right.

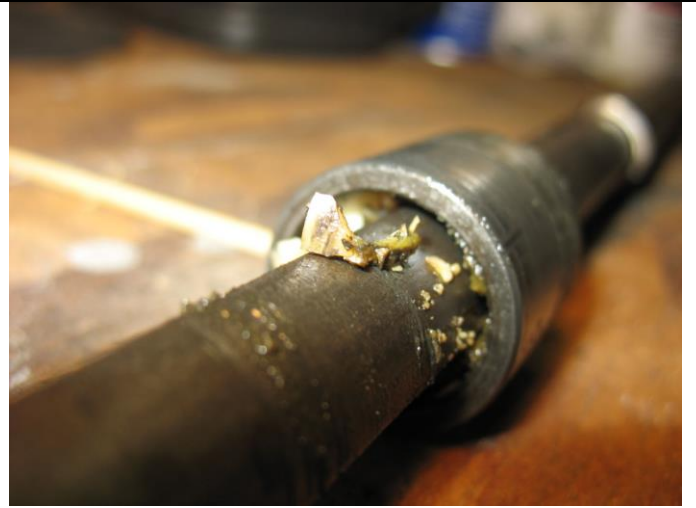
My problem was with the inner bearing race that is pressed onto the column. Mine had rotted with age and had actually started to crumble...

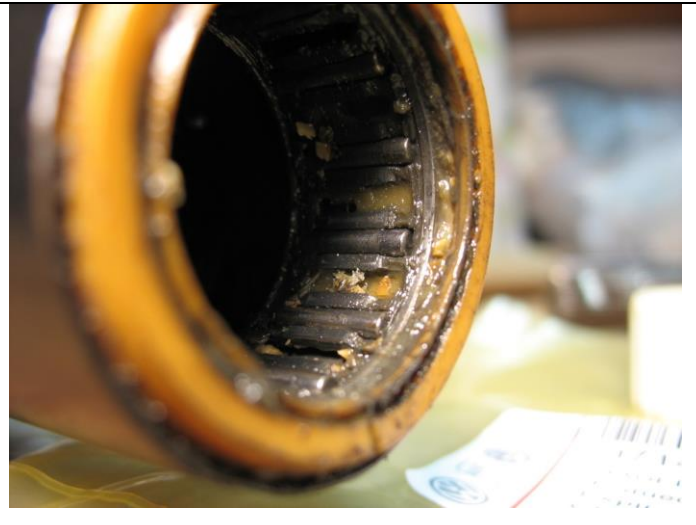
As a result, over time, that inner race had walked itself up the steering column, little by little, turn after turn, until finally it had walked up so high that it had freed itself from the outer needle-bearing race in the tube. Bam! There's your problem! Yummy...

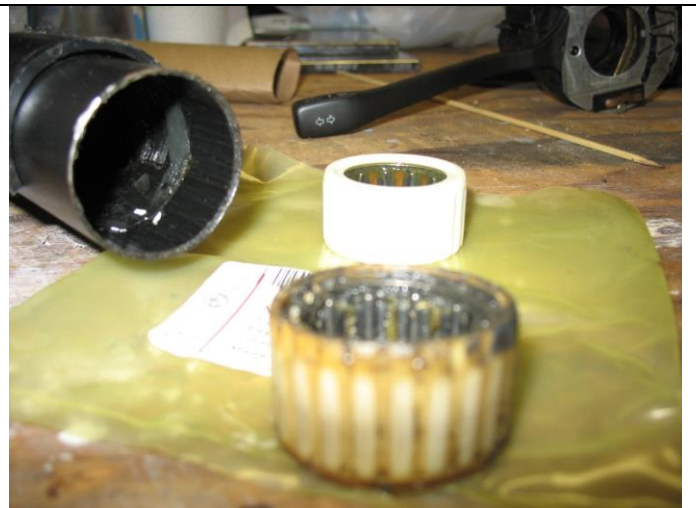
You can see where my needle bearing had actually slipped downwards, indicated by the distinct line of the discolored area vs. the more 'white' area as compared to the new bearing in the background.

I searched the garage for a suitable length of pipe to use as a drift to drive out the needle bearing. What to do? I ended up using (and I s*** you not) the lower half of my beach umbrella – whose diameter fit the race nicely – a couple taps with a hammer and out it came.

To install the new needle bearing, I simply placed the bearing on the carpet, stood the tube atop it, and smacked the end of the tube w/a hammer a couple times until the needle bearing was flush with the end of the tube. Oh, and I held a wooden block atop the tube to avoid deforming it with hammer blows.

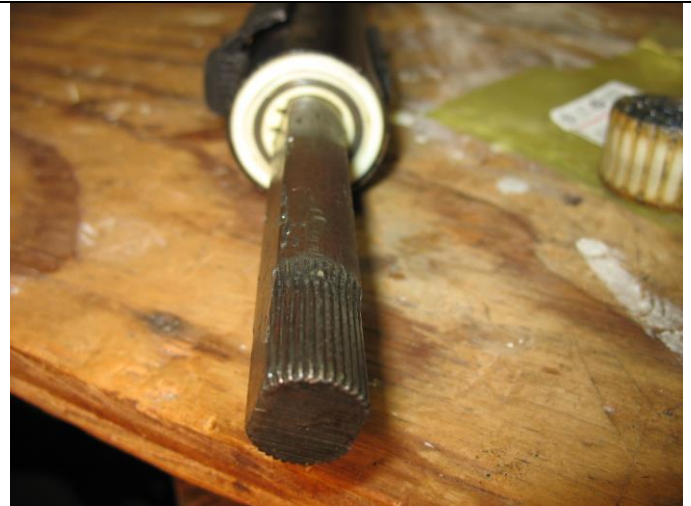
Once you're sure everything is lined up, go ahead and reinstall the housing and lock it down. Now you have fixed the length of your column and eliminated any end play... there should be none.

^Almost like a radial shaft seal in its tightness.

The inner race on the column was installed using a large deep-welled socket as a drift to drive the race into place on the shaft. A nice snug fit was my reward after a couple tap-tap-taps with the hammer.

I did a couple test fits before I got the location of the race just so. By that, I mean I had to grab the tube and reinstall the lock housing-end and pull the column down into the tube (as if it were assembled) to see if the race was at the proper 'depth' so as to be fully contacting the needle bearing.

Once you've got the inner race on the column where you want it, you **must** be sure to install the column with the notched-out splined end in the proper orientation for mating with the u-joint shaft.

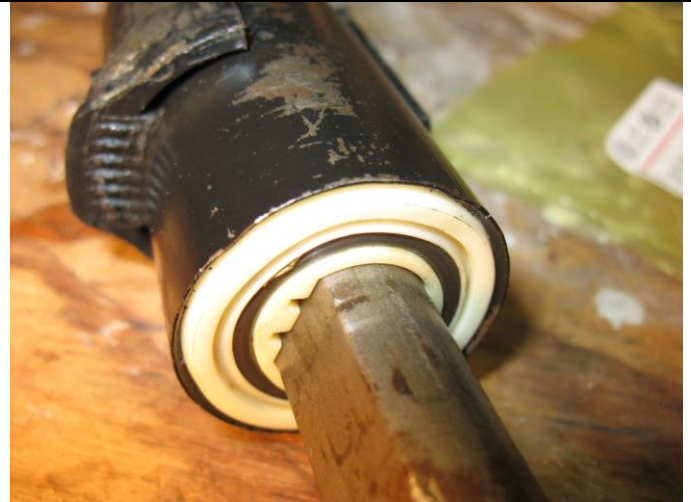
It helps to pry open the clamping end of the U-joint a bit before attempting to slide the column back in place... a little lube wouldn't hurt either.

If you oriented things properly when putting on the lock housing then everything should drop back into place like a hot... well, you know.

Finish the rest of the install as per that linked thread at the beginning of this thread and you should be golden.
