Project CABRIO

Solving the "shake and rattle," with just a little dough!

By JEFF HOLIFIELD

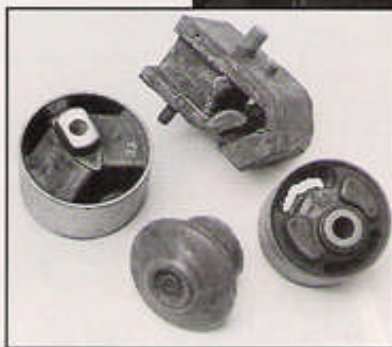
LEFT, four motor mounts are used on the Cabriolet. The large-diameter right motor mount is prone to failure. The mount shown here is an improved version of the original.

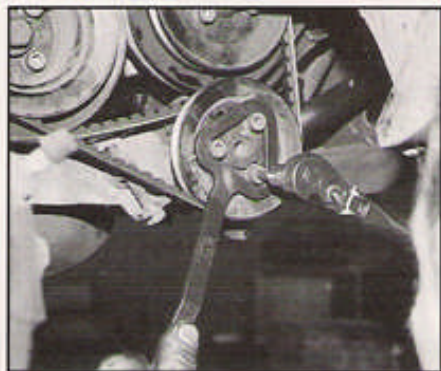
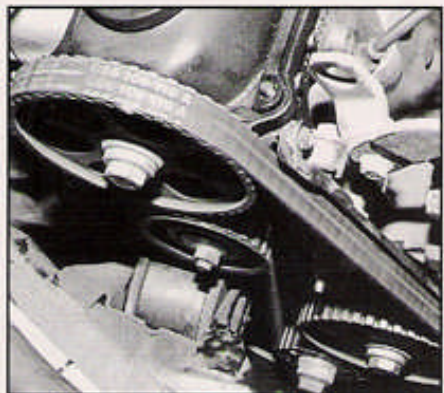
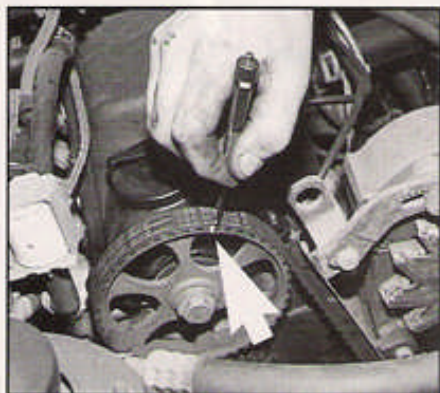
ABOVE, to replace the right motor mount, the timing belt must be removed, which also means all the lower pulleys and V-belts must be removed. **FAR LEFT**, there she blows! The motor mount is located directly under the timing belt tensioner. Space is tight to say the least. **LEFT**, if the drive belt is to be reused, Mesa West puts a dab of paint on the belt at all three sprockets.

To facilitate removal of the right motor mount carrier, the timing belt must be removed, as well as the intermediate shaft sprocket. Last month, we covered in detail the removal and installation of the timing belt, so we will concentrate more on the mount removal specifics in the photos. Nothing too complicated, just a lot of work to remove the mount carrier from the engine.

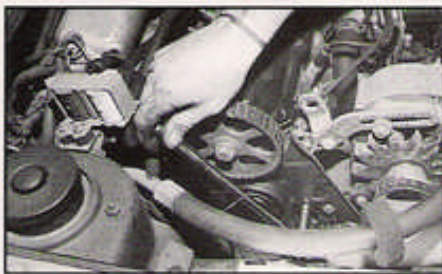
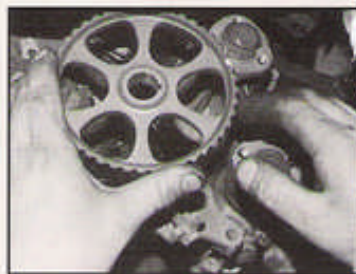
LEFT, once the belt is removed, the two bolts holding the mount carrier to the face of the engine are removed, as is the rear drive belt cover. **RIGHT**, the intermediate shaft sprocket must also be removed. To loosen the mounting bolt, use an extra 3/8-inch drive ratchet fitted with a long 13mm socket through the sprocket to keep it from spinning.

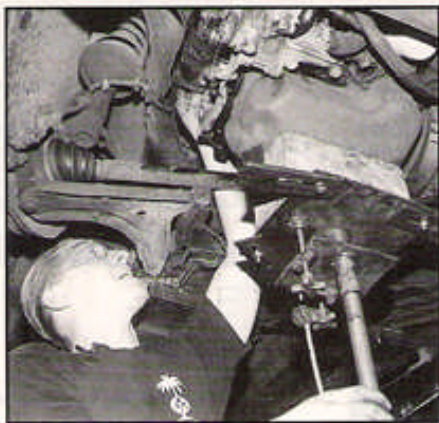
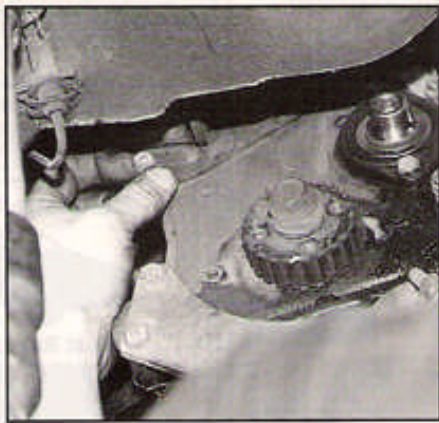
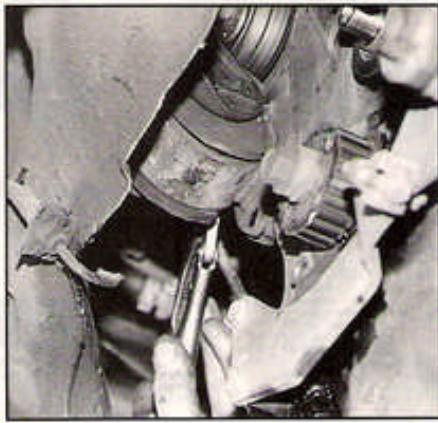
ABOVE LEFT, with the first two mount carrier bolts removed, it is a good time to take pressure off the motor mount via a floor jack. **ABOVE CENTER**, there are three more bolts securing the carrier to the engine. One more on the face, directly under the mount. **ABOVE RIGHT**, and two on the backside of the engine. These last two can be tricky to spin out by hand, and pliers may be required to get a grip, once broken loose.

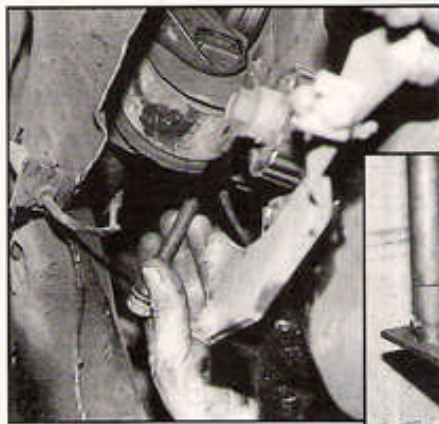
ABOVE, with the carrier completely detached from the engine, remove the single large bolt that secures the mount to the chassis. Slowly work the mount out until it is free.

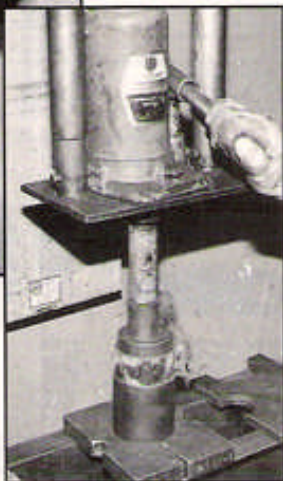
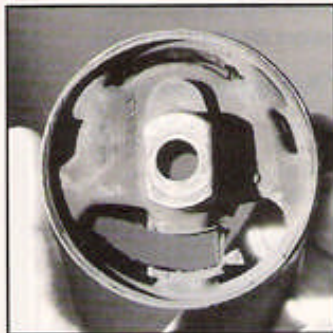
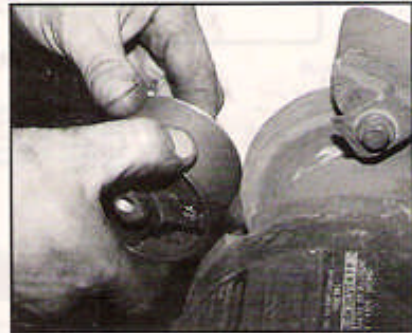
LEFT, the old mount must be cut, or pressed out from the carrier. Mesa West has a special tool that makes this chore a snap. **ABOVE CENTER**, our original right motor mount was totally collapsed, even though the rubber looks great. **ABOVE RIGHT**, before pressing in the new motor mount, a chamfer is ground all the way around it to help center it.

The next hoop to jump through is removing the actual motor mount from the carrier, and then pressing the new one in. Genuine Volkswagen Service centers have a special tool (used in conjunction with a hydraulic press) to remove and install this mount from its carrier, but very few independent shops do. Fortunately for us, nearby Mesa West German Auto Center, in Costa Mesa, California (714/645-2374), is one of those lucky few.

After seeing the ease at which the motor mount is pressed out, and in, with this special factory tool, we feel it is well worth the few extra dollars to a home mechanic to remove the mount carrier from the car themselves, and then take it to a nearby VW dealer (or shop like Mesa West).

For those without such a place near home, the metal ring of the mount (not the carrier) can be cut in a pie-shape fashion to get the mount out. Then a hydraulic press can be used to slowly press the new mount in, with the help of strategically placed bars to provide required clearance for the protruding center portion of the mount. We have heard that a very large vise will also get the job done, but this is potentially dangerous with the pressures involved, and we do not recommend this route. Once again, for our dollar, it's well worth having a professional, with the right tools, do the job correctly.

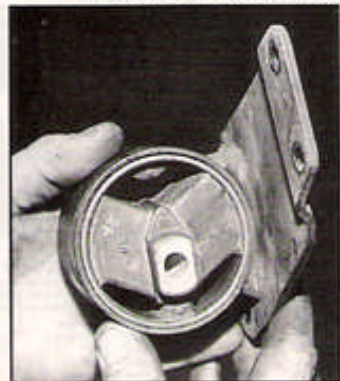
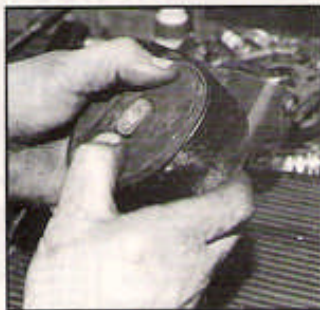
FAR LEFT, the new Genuine VW Parts mount is much stouter than the weak original unit Volkswagen used on the assembly line. Note mount orientation when properly installed. **LEFT**, these rubber mount covers are often decayed, and should be replaced before reinstalling the new mount. **RIGHT**, getting the mount back in place is a real fun job ... not!

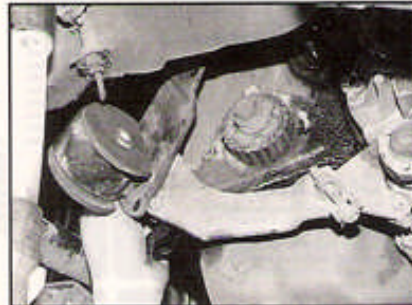
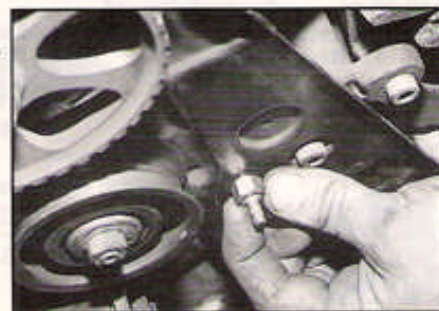
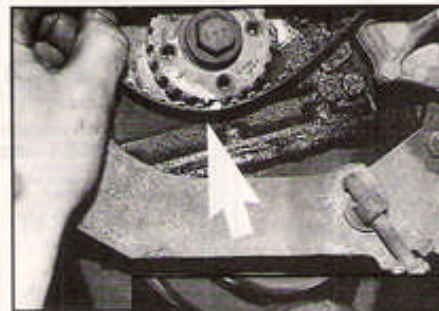
ABOVE, installation of the motor mount carrier is in reverse of its removal. The engine support jack may have to be raised, or lowered some to get all the screws in. Also, install all of the carrier's bolts before tightening any of them. **ABOVE RIGHT**, the timing belt is reinstalled by matching the paint markings that were put on before removal. **RIGHT**, the procedure is finished like a normal timing belt change from here.
